Manhole Inspection Summary

Manhole # S17MM_008MH

Insp Date: **6/6/07 11:14 AM**

Location Address: **2221 WINDSOR AVE**

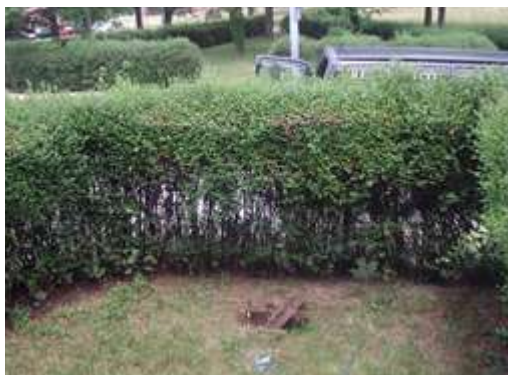
Location View

Comments **IN YARD OF 2221, SURROUNDED BY BUSHES**

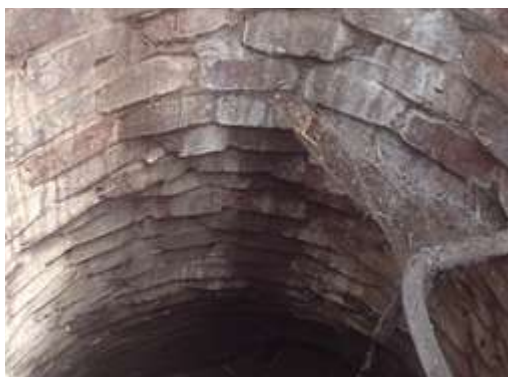
Defect 1

Infiltration: ☐ None ☐ Joint ☐ Cracks ☐ Mortar ☐ Roots ☒ Wall

INFILTRATION OF CORBEL WALL

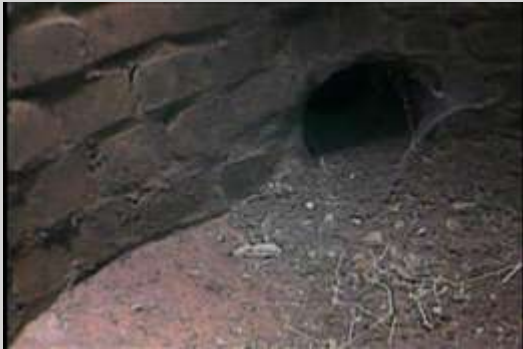
12 O'Clock Outflow

DEBRIS IN CHANNEL
